SAN ONOFRE'S STEAM GENERATOR FAILURES COULD HAVE BEEN PREVENTED

May 14, 2012

FAREWINDS ASSOCIATES

REPORT COMMISSIONED BY FRIENDS OF THE EARTH

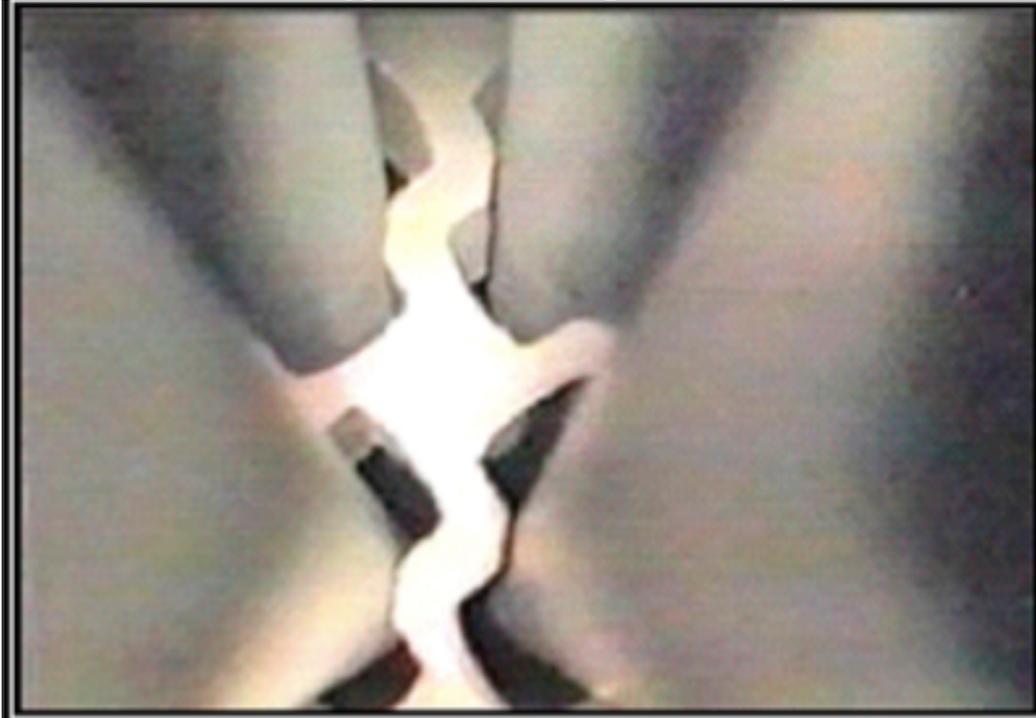
Figure 1: Broached Tube Support Plate - Designed To Keep Tubes From Rattling

The flow resistance of the Mitsubishi broached plate is *much higher* than that of the original Combustion Engineering egg crate design because the tubes are so tightly packed in the original CE San Onofre steam generators. By reviewing the documents thus far produced, it appears that due to Mitsubishi's fabrication experience with broached plates, both Edison and Mitsubishi missed this key difference in the design and fabrication of the new San Onofre steam generators.

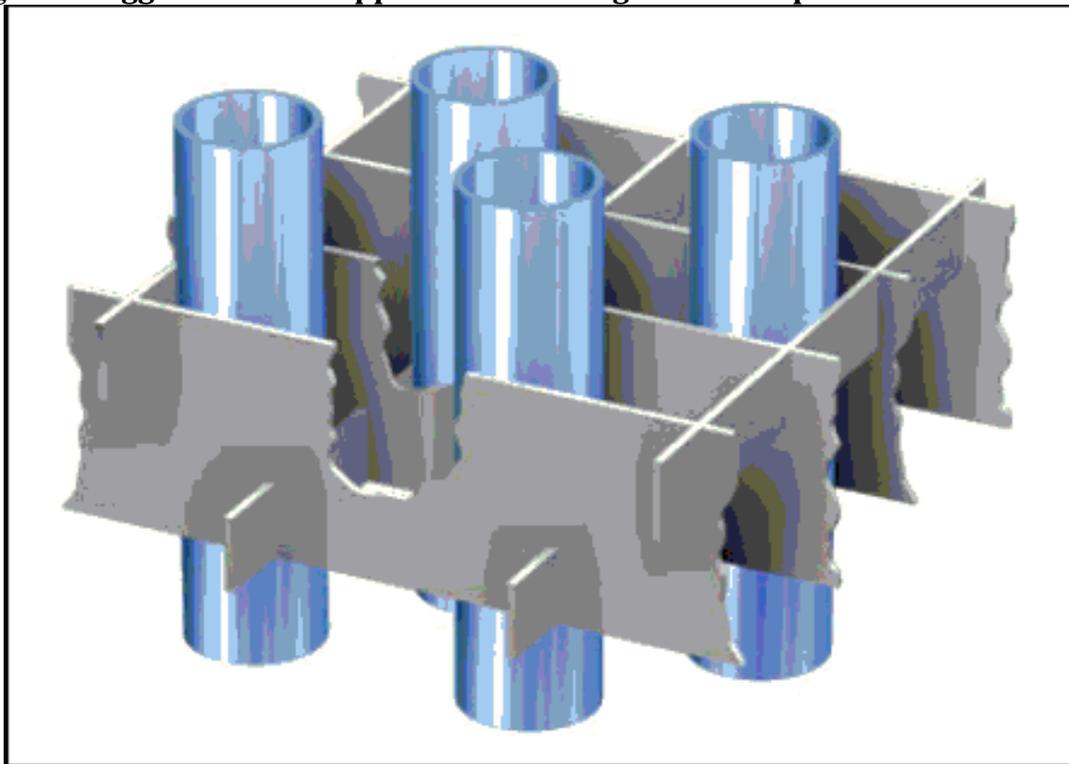
Figure 2: Eggcrate Tube Support Plate - Designed To Keep Tubes From Rattling

The original steam generators designed and manufactured by CE for San Onofre were successfully operated 28 years. Moreover the original steam generators had a triangular tube pitch pattern, very closely packed U-tubes, and unique egg-crate tube supports that kept the tubes from vibrating and colliding. The pitch to diameter ratio of tubes in the original CE generators is dramatically different from any of the Westinghouse generators fabricated by Mitsubishi. Moreover, an NRC licensing review would have identified the fact that the Mitsubishi computer design code, which is based upon Westinghouse models, was not appropriate for design changes to the San Onofre replacement steam generators originally designed by CE.
